Docket No. 217 – Development and Management Plan Inspection

Northeast Utilities Service Company Certificate of Environmental Compatibility and Public Need for the construction of a 345-kV electric transmission line and reconstruction of an existing 115-kV electric transmission line between Connecticut Light and Power Company's Plumtree Substation in Bethel, through the towns of Redding, Weston, and Wilton, and to the Norwalk Substation in Norwalk, Connecticut.

Date: March 2, 2006

Location: Transition Stations: Hoyts Hill, Archers Lane, Norwalk Junction

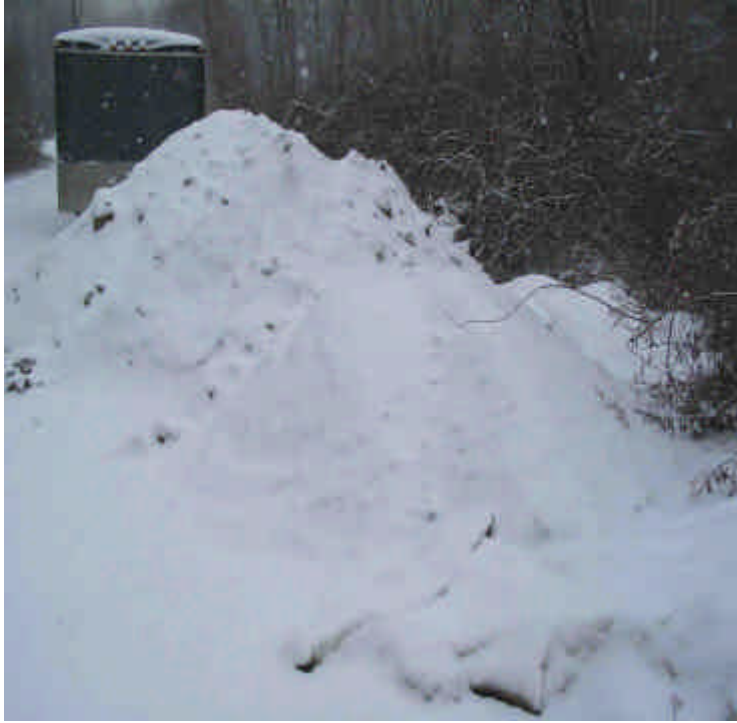
Hoyts Hill Transition Station: Photo on the left shows a small stockpile placed across Rt. 58 from the transition station. Controls should be placed at the base of the pile. Photo shows an overview of the station pad from Rt. 58. 3/2/06

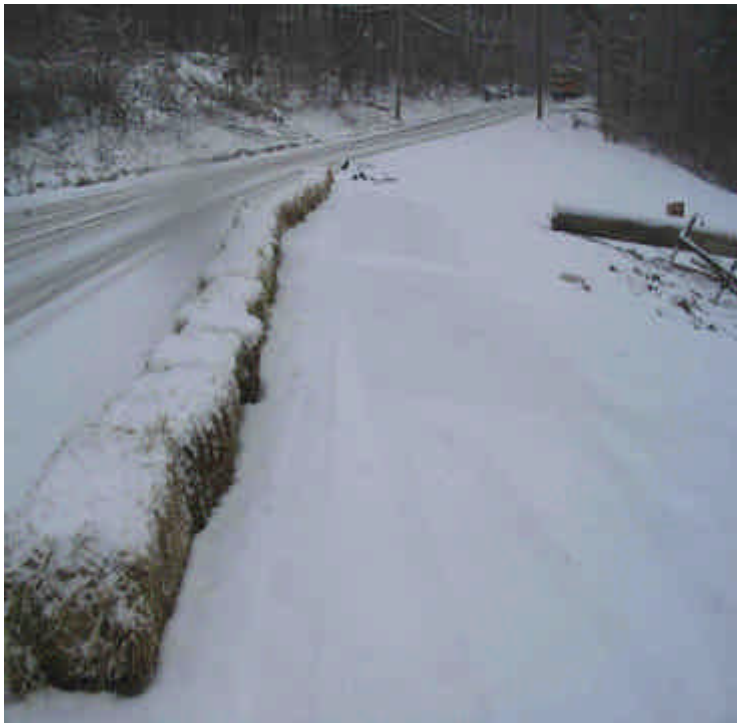
Areas of Inspection	Observation	Recommended Action
Access Roads and Adjacent Roadways	<p>- Hoyts Hill: Access is gained off Hoyts Hill Road. Sedimentation had previously been an issue at access point. Additional haybales were installed in an attempt to control this. 3/2/06.</p> <p>- Crews continue to be on site to drill excavations and install structures. 2/16-3/2/06.</p> <p>- Archers Lane: Conditions were muddy. Water levels at the wetland crossings on the access road to the ROW had remained constant since the last site visit. 3/2/06.</p> <p>- Trenching continues within the access drive into the station for 345kV installation. Sediment is being stockpiled along the trench. 2/23-3/2/06</p> <p>- Norwalk Junction: Sediment tracking did not appear to be an issue at this time. The snow and sediment piles pushed into the swale remain from the last snow event remain. 2/16-3/2/06.</p>	<p>- Ruts should be smoothed out as necessary. 12/30-3/2/06.</p> <p>- If the haybales don't improve the situation, additional stone may be necessary. 3/2/06</p> <p>- Sediment accumulation in the wetlands will have to be addressed. 2/2-3/2/06.</p> <p>- Snow removal on the access road for the ROW work caused sediment to the wetlands . 2/16-3/2/06</p> <p>- The stone wall and natural barriers here appear to keep any sediment from the wetlands along the drive. Continue to monitor 2/2-3/2/06</p> <p>- Continue to monitor Rt. 7 at the main access pad. 3/2/06.</p> <p>- See erosion control section for more details on the snow/sediment. 2/16-3/2/06</p>

Photo on the left shows where additional haybales were installed along the Hoyts Hill and the access drive to try and reduce erosion and sedimentation here. Photo on the right shows the outlet and gully with haybale check dams in place for dewatering. 3/2/06.

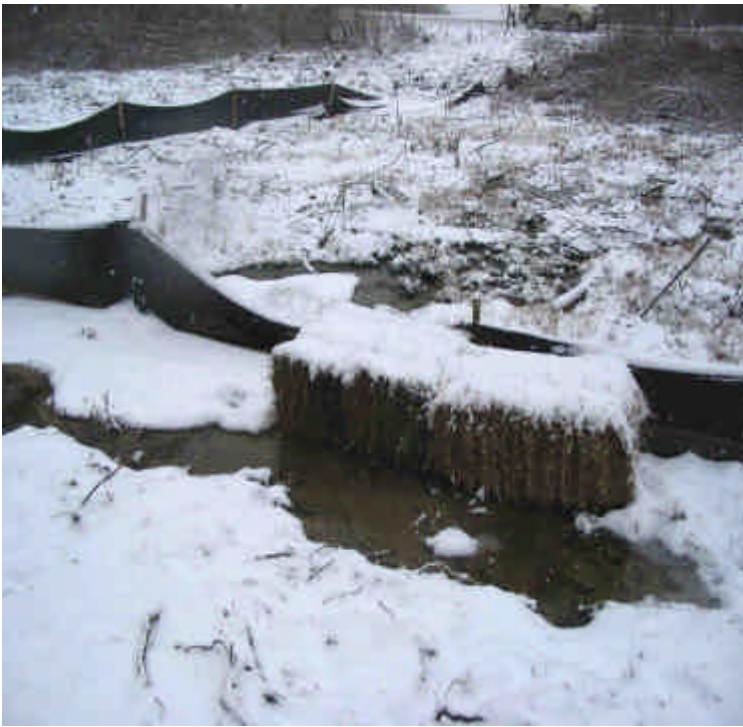
Erosion and Sediment Controls (includes inspection within 24 hours of a storm event)	<ul style="list-style-type: none"> -Hoyts Hill: Most of the perimeter silt fence remains in fairly good shape. 3/2/06 - Sedimentation continues to overwhelm the fence in the spot previously noted. Sedimentation continued to build through the fence and in the wetland.1/19-3/2/06 -Haybales were installed at this spot as recommended and contractors were going to be removing the sediment by hand. 3/2/06 - The erosive gullies remain under snow cover on both the northern and southern slopes resulting in increasing sediment deposits along the 	<ul style="list-style-type: none"> - Repair/restaple the silt fence if necessary. 2/16-3/2/06 - Continue to repair or install additional controls in the spot which washed through ASAP. More importantly- control the source of sedimentation (gullies) 1/19-3/2/06 - These controls are even more important now that dewatering is occurring. 2/23-3/2/06 - Gullies should be repaired and a stronger method of stabilization, such as erosion control mats should be considered. 10/27-3/2/06 -Extension of the outlet stone pad and restoration of erosion

Dewatering	<p>-Dewatering has since occurred at Hoyts Hill. Haybales have since been placed in front of the sediment spot at the silt fence but sediment accumulation remains. 3/2/06</p> <p>- Dewatering was not necessary at Archers Lane at the time of inspection for the 345kV trenching. Haybales remain installed across the swale. 3/2/06</p> <p>- Foundation excavation at Norwalk Junction has created the need for dewatering. Well</p>	<p>-The silt fence still needs to be toed in at the sedimentation area and sediment will be removed by hand in the near future 3/2/06</p> <p>- Since water is still turbid by the time it reaches this spot, a filter bag should be considered above the CB. 2/16-3/2/06</p> <p>- Water is directed to a stone swale which infiltrates to a drainage pipe under the access road. Water levels in the wetlands have remained constant since the last visit. 3/2/06</p> <p>-The pipe allows the water to run the length of the swale for further filtration. 3/2/06</p>

Hoyts Hill: Photo on the left shows where haybales were installed at the sediment breakout as recommended. Contractors will be removing the sediment by hand in the near future. Archers Lane: Photo on the right shows a view of the access drive where 345kV crews are trenching. 3/2/06.

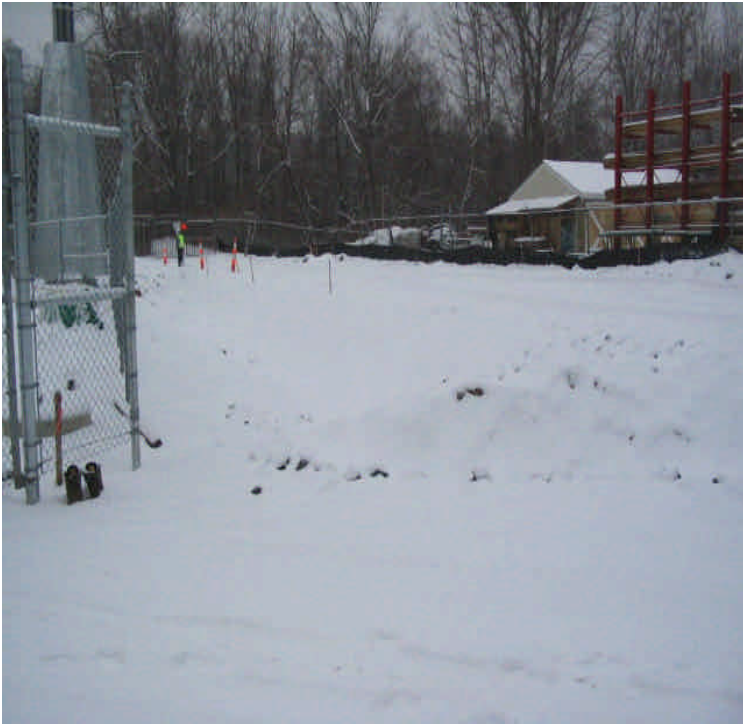
Areas of Inspection	Observation	Recommended Action
	<p>3/2/06</p> <ul style="list-style-type: none"> - Snow piles with sediment remained directly in and along the swale. This introduces more potential for turbidity. 2/16-3/2/06 - Erosive gullies/soil slumping remain in a number of locations along a portion of the drainage swale due to site run-off, resulting in further sedimentation to the swale. 12/30-3/2/06. Haybales remained in the inlets. 2/2-3/2/06 -Need for dewatering has resulted in a riprap swale built to the Norwalk River. An outlet pipe from the well points was in place. 2/23-3/2/06 	<ul style="list-style-type: none"> - These piles still need to be pulled back from the swale to prevent potential sedimentation as they melt. 2/16-3/2/06 - The erosion control matting on the swale likely needs to be extended up and over the top of slope to prevent further erosion until the growing season. 12/30-3/2/06 - Be sure to restore this area when work is complete. 2/16-3/2/06

Norwalk Junction: Photo on the left shows a view of the swale where snow/sediment piles from the last storm remain in the swale. Photo on the right shows where the outlet pipe from the well points on site dewaterers to the riprap swale at the river. 3/2/06.

Additional Observations	- When snow removal is necessary, place it in areas away from the flow patterns of run-off- i.e. not in swales which can drain to wetlands and carry the sediment.

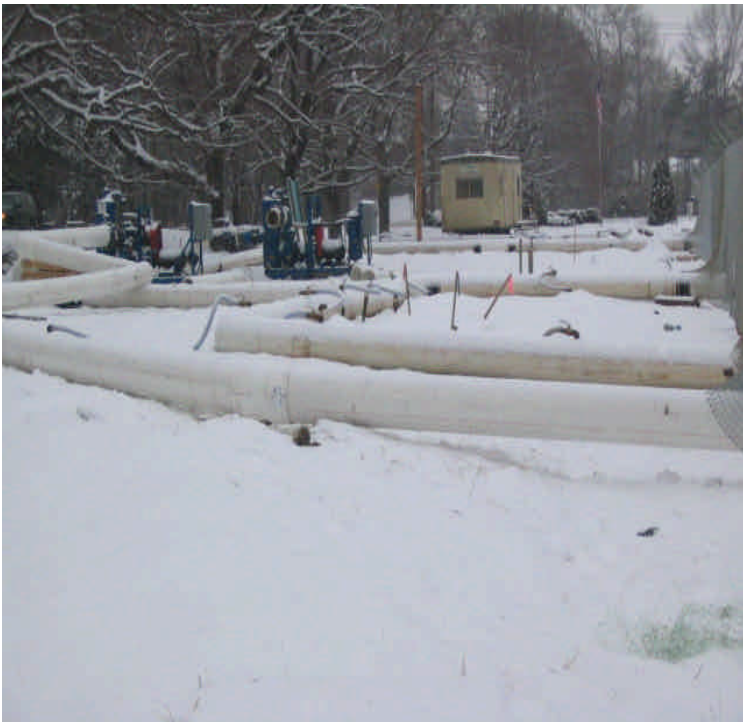
Photo on the left shows the network of pipes to dewater the well points to the main pipe that outlets at the river. Water taken from these points this way does not pick up turbidity from the trench that is seen in typical dewatering. 3/2/06
